Report on July 30-31, 2012 Storm Event at the Genesis Solar Energy Project Construction Site

Eric Veerkamp, Compliance Project Manager
Mike Conway, Engineering Office
Siting, Transmission and Environmental Protection Division

Summary

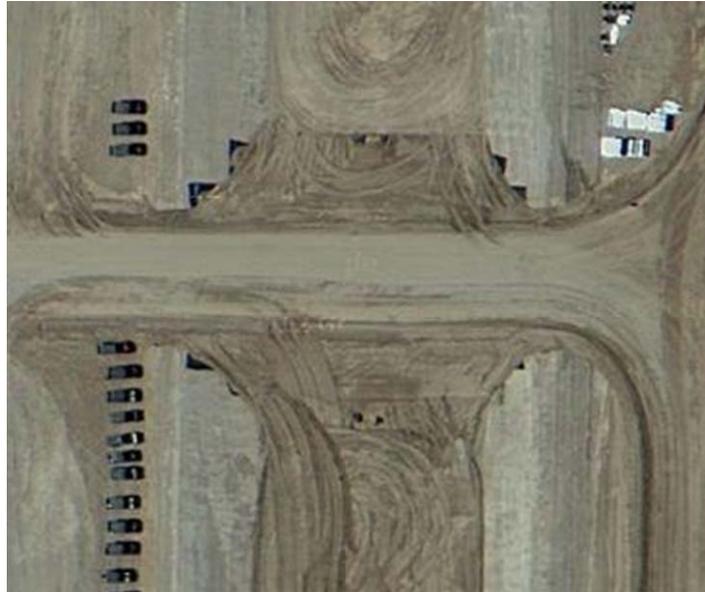
To ease the movement of equipment during the construction phase, two of the channels, the central (known as Channel B/C) and the eastern (Channel D) channels were filled in with temporary earthen land bridges (see Figures 1 and 2) that had several 12-inch culverts designed to drain water in the channels through the temporary bridges. From evidence collected at the site, these culverts were insufficient for the rain event, causing the temporary land bridges to act as channel dams which redirected storm water flows into the site, causing much of the damage². The temporary bridges have been removed, and there are no current plans to utilize this type of crossing in the future.

Figure 1. The temporary land bridge across Channel B/C as shown in June 2012 (from Google Earth).

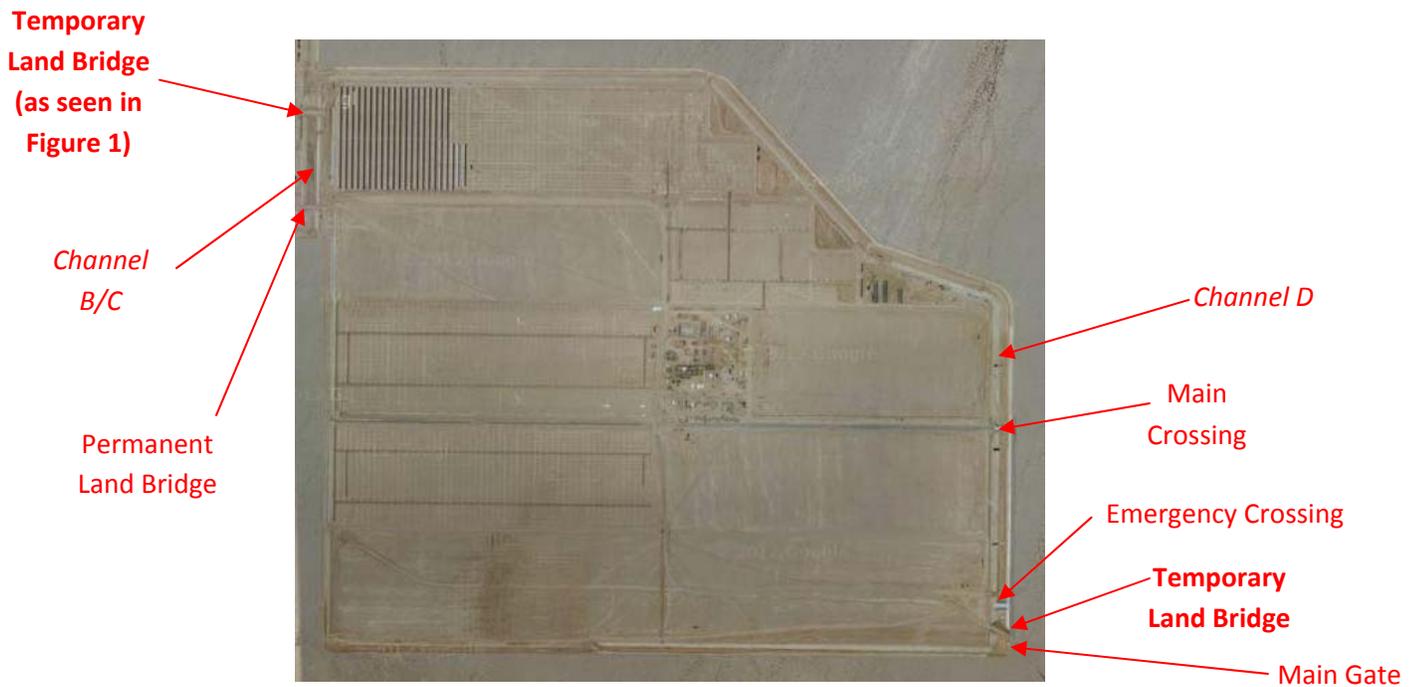
Figure 2. Selected features including the temporary land bridges traversing Channels B/C and D as shown in June 2012 (from Google Earth).

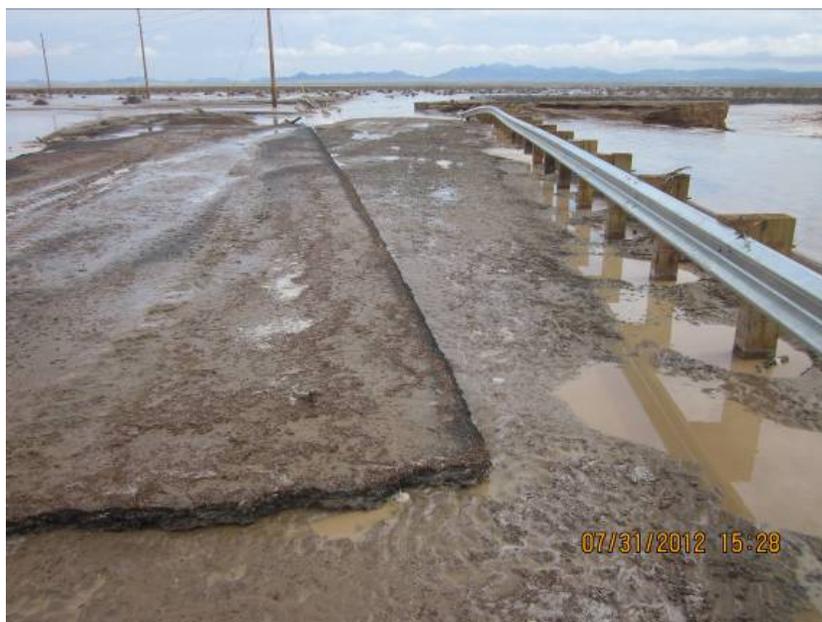
Figure 3. Damage to access road at main entrance.

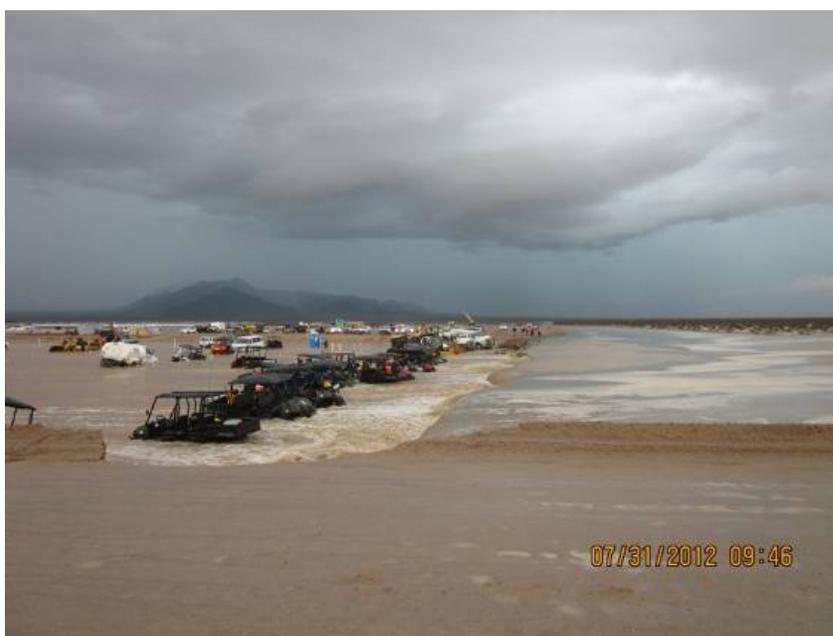
Figure 4. Water overflowing channel at the common area parking lot due to earthen crossing (photo taken atop crossing).

- Discontinue the use of earthen crossings that don't provide sufficient capacity for channel flow.
- Install a more sophisticated weather system to track and record weather on site.
- Require installations of portable bridges if temporary channel crossings are still needed.

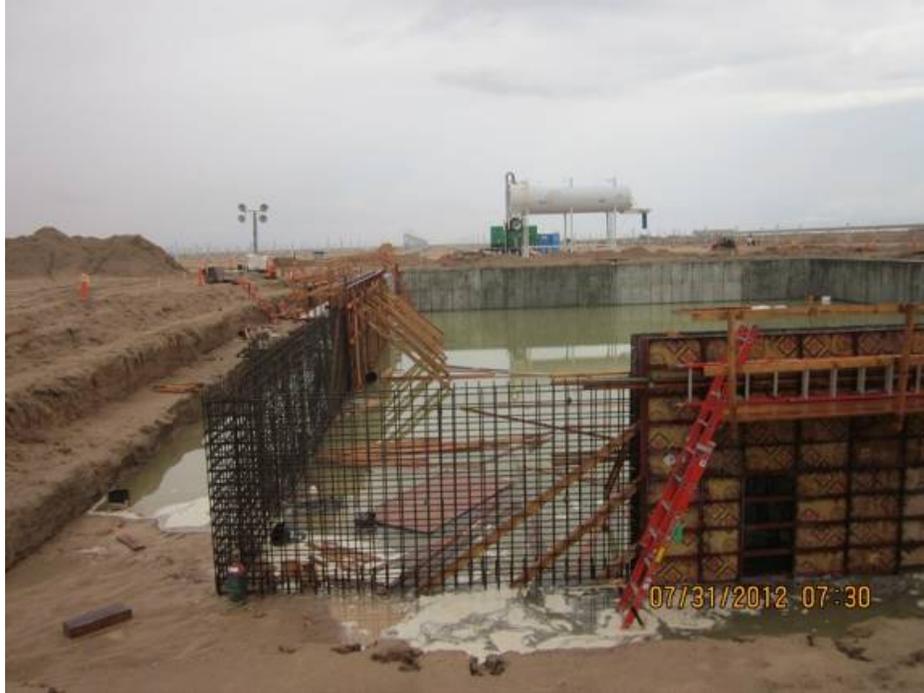
Figure 5. Administration building foundation in Power Block 1.

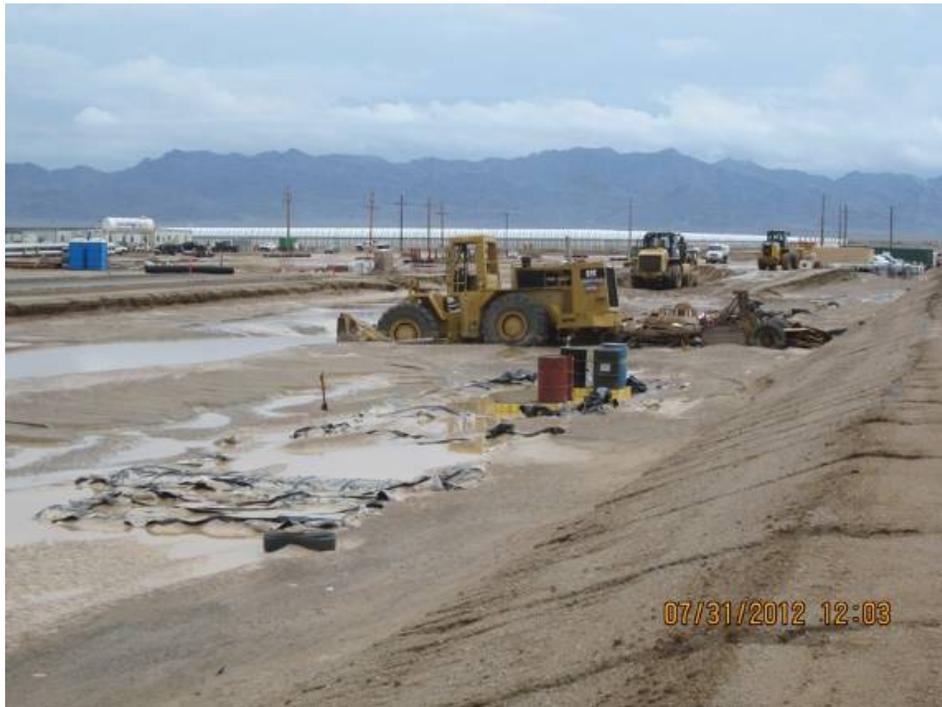
Figure 6. Equipment flooded in the common area.

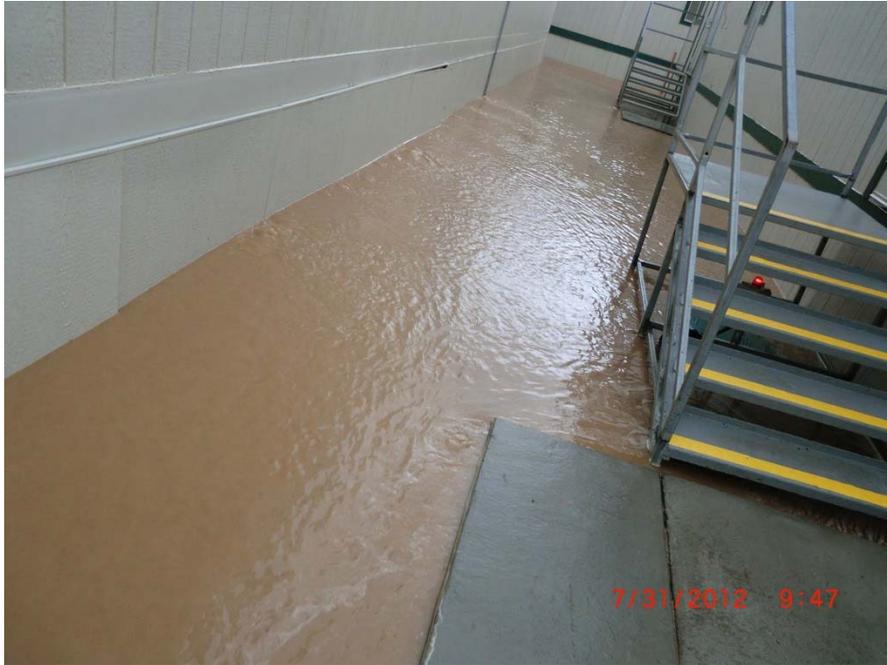
Figure 7. Flood waters in the common area near Channel B-C.

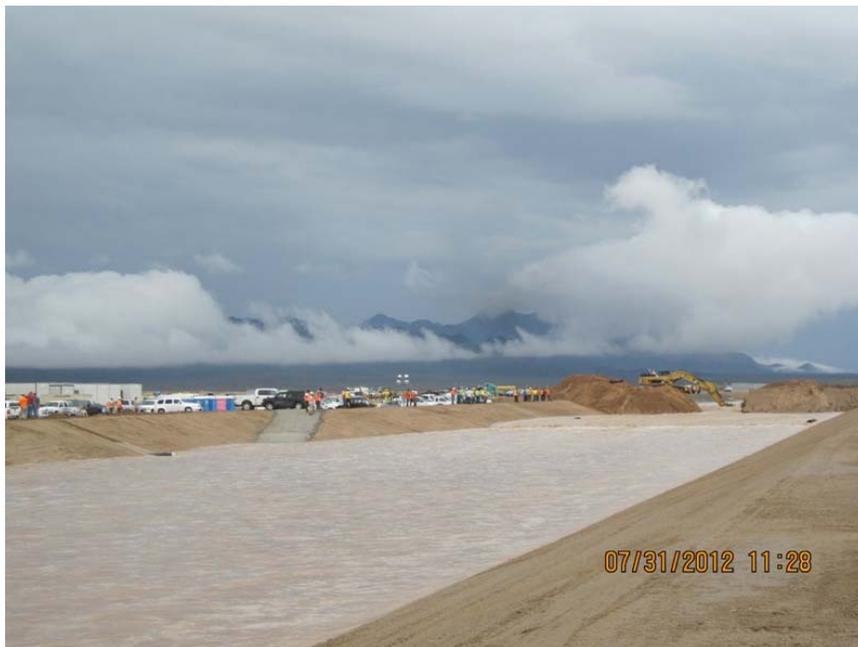
Figure 8. This photo shows the temporary earthen crossing located near the common area/trailer city (Channel B/C) being removed after the storm; the photo above is looking to the north. This temporary earthen crossing (and one other located near the main plant entrance) acted as dams during heavy flows, re-directing flood waters towards the site, causing the majority of flood damage to the site.

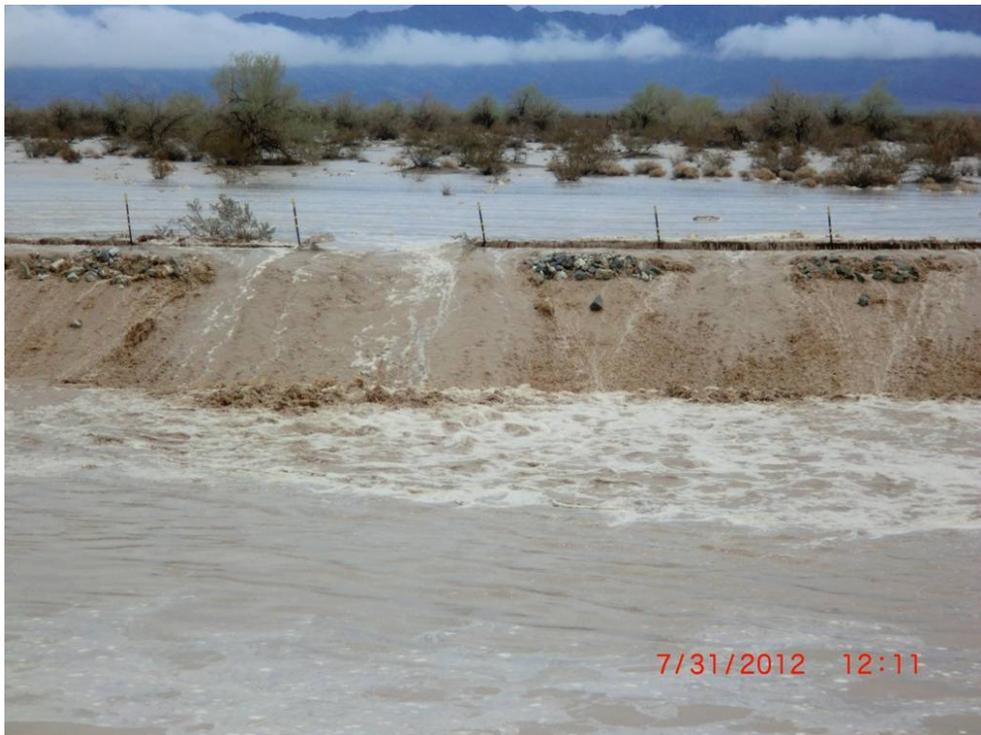
Figure 9. Water rushing into Channel A.

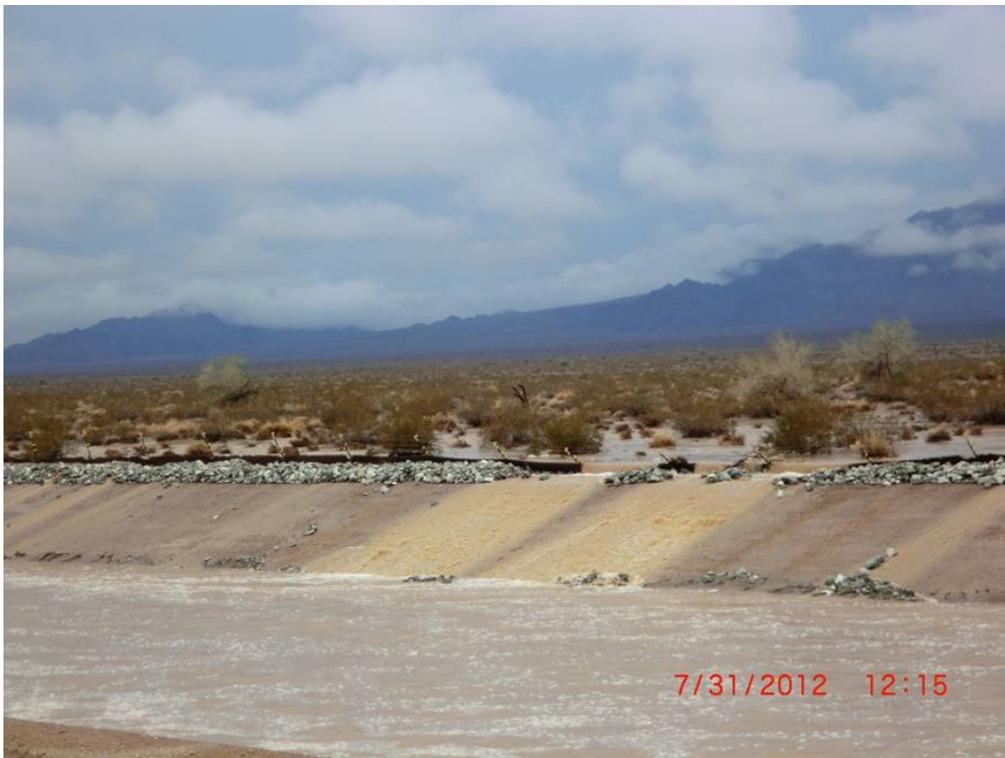
Figure 10. Water rushing into Channel A.

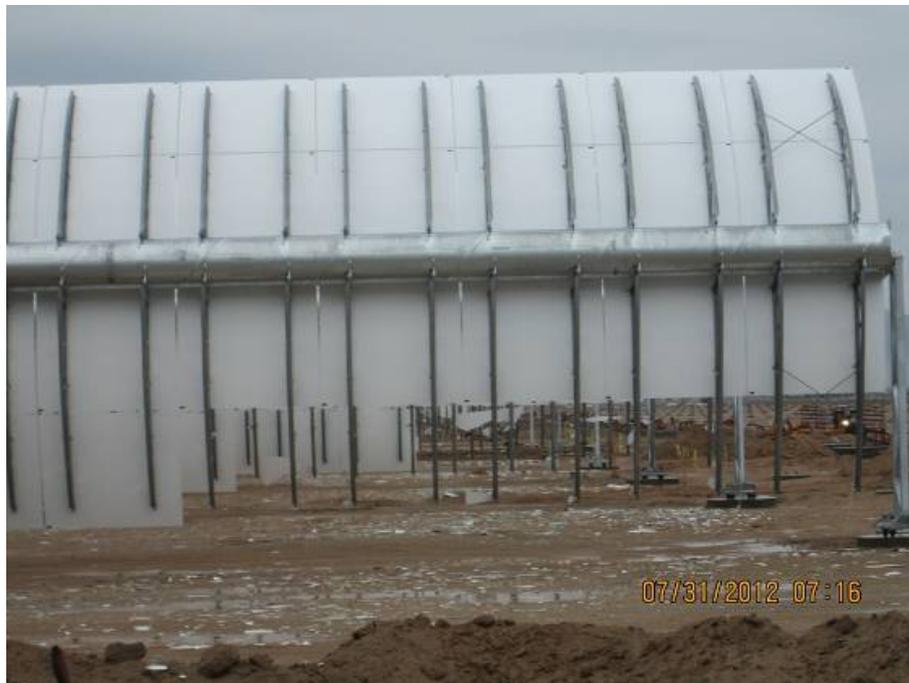
In addition to damage caused by water, some of the mirror arrays were damaged as shown in Figures 11 and 12. It is believed that this damage was caused by localized winds.

Figures 11. Damage to mirror arrays (July 31, 2012)

- A total of 46 solar elements were affected, with a total of 195 mirrors broken. According to NextEra sources, these repairs can be made in the field. On-site personnel reached a conclusion that the cause of the damage was sustained winds of 55 mph that may have been muted had the wind fence been in place.

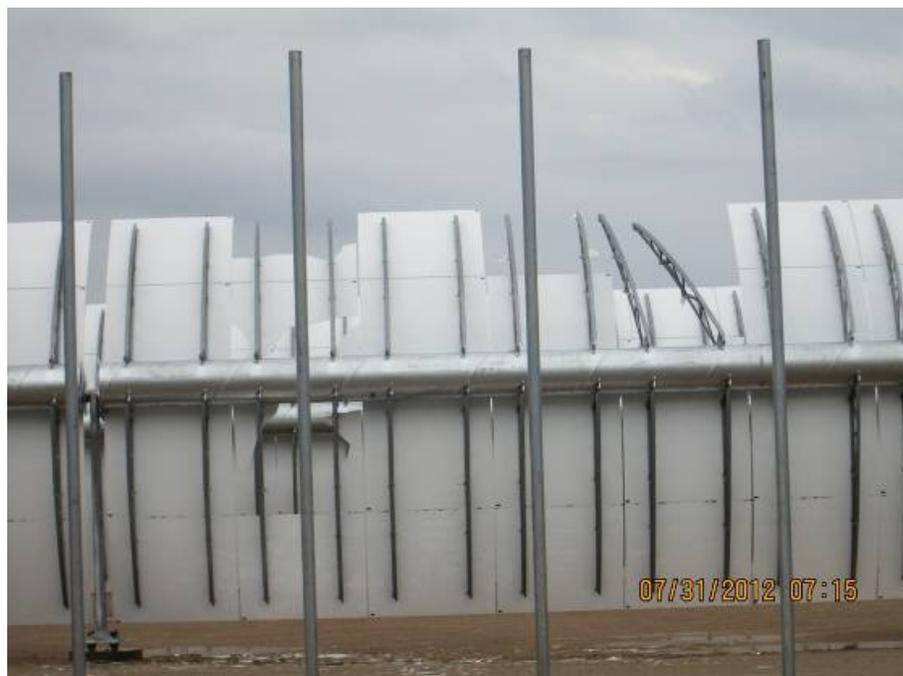
Figure 12. Mirror damage, poles in foreground are for as-yet-to-be completed wind protection fence (July 31, 2012)

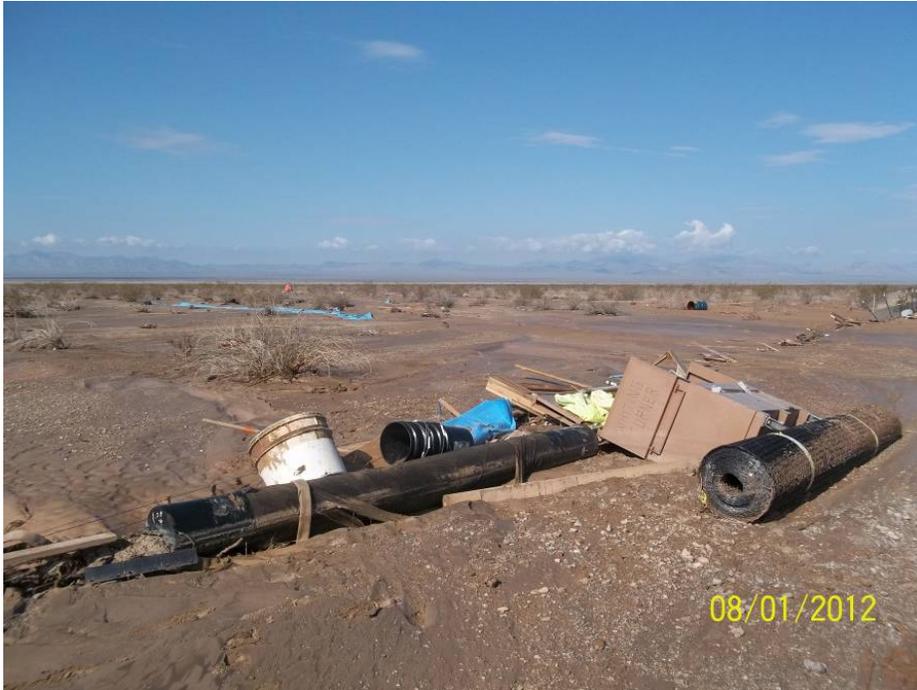
An example of downed fencing at the site is shown in Figure 13. Additional images of damage are shown in Figures 14 through 19³.

Figure 13. Tortoise fence was damaged along the south side at the outfall by debris (August 1, 2012).

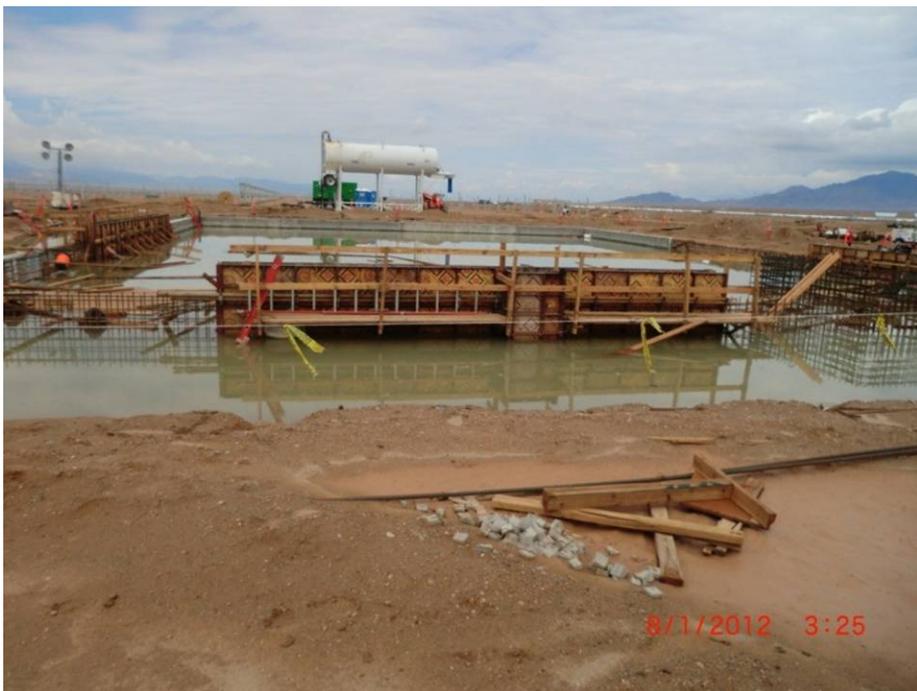
Figure 14. Administration building foundation in Power Block 2 (August 1, 2012).

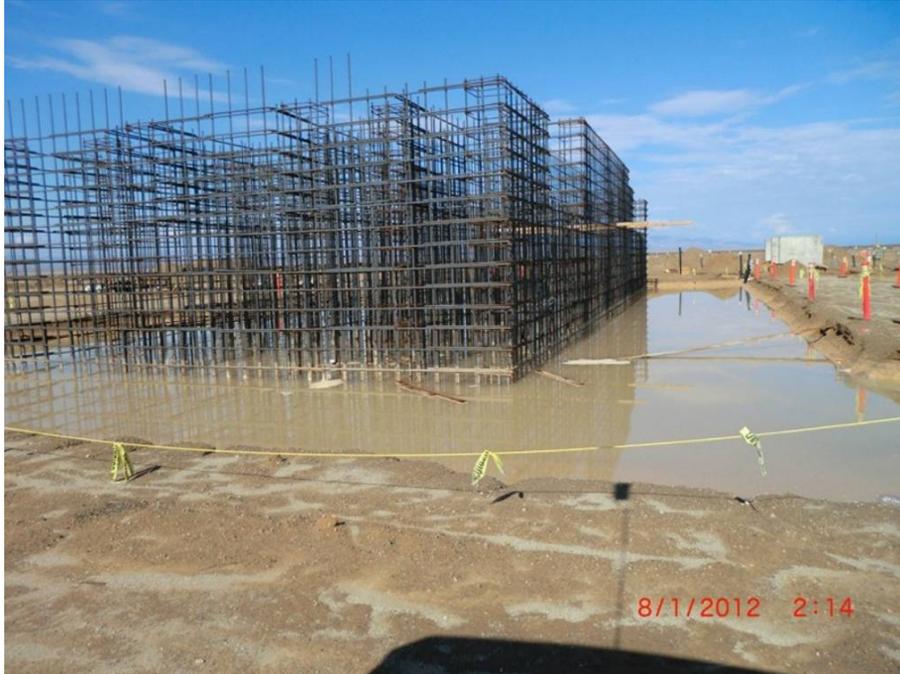
Figure 15. The steam turbine generator foundation in Power Block 1 under water after the storm (August 1, 2012).

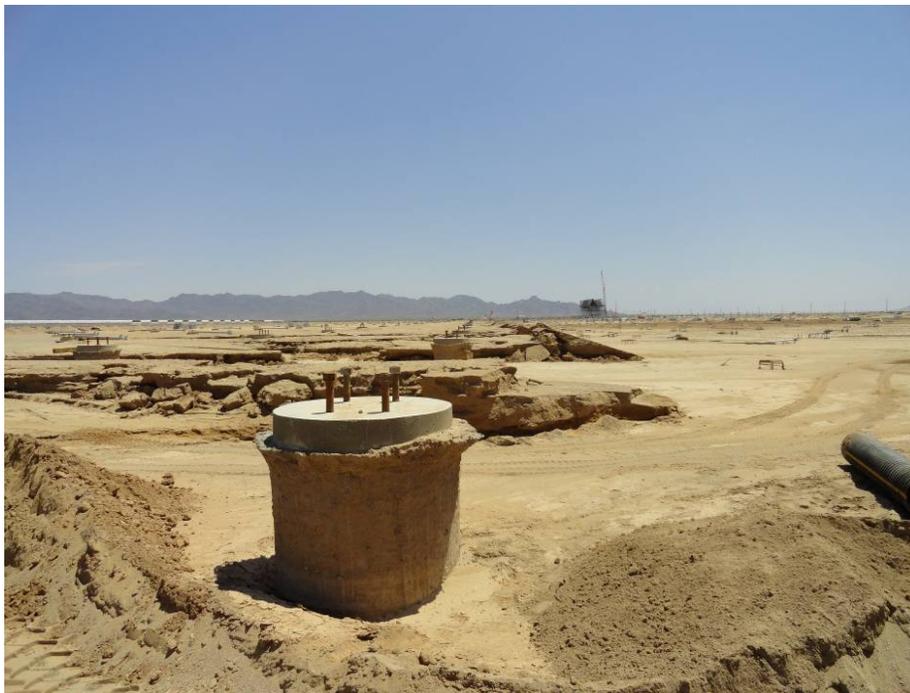
Figure 16. Caissons in Unit 2. Erosion around the caissons occurred because water filled up Channel B-C and flowed around the earthen berm (August 6, 2012).

- 80 caissons with cages (steel support structure) needing to be pulled for repair and/or reconstruction;
 - 120 caissons drilled but without cages need to be filled, compacted and rebored (redone)

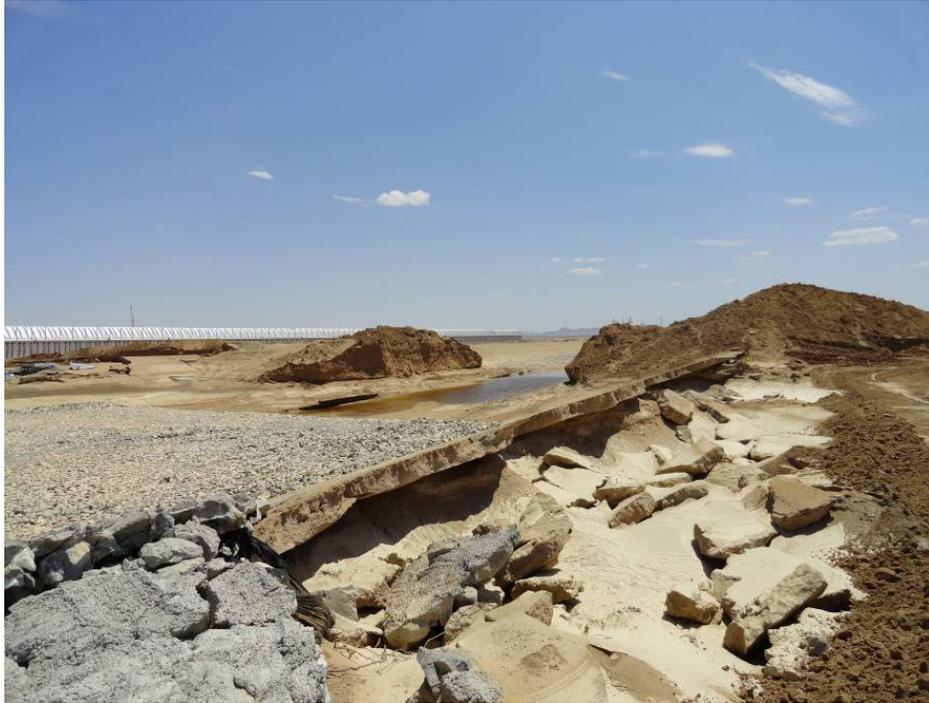
Figure 17. Looking south-southeast at the earthen berm constructed in Channel B/C. Flooding and receding flows damaged the soil cement lining the sides of the channel (August 6, 2012).

- Flood diversion channels themselves sustained damages from floodwaters overflowing their banks eroding the soil cement lining the sides

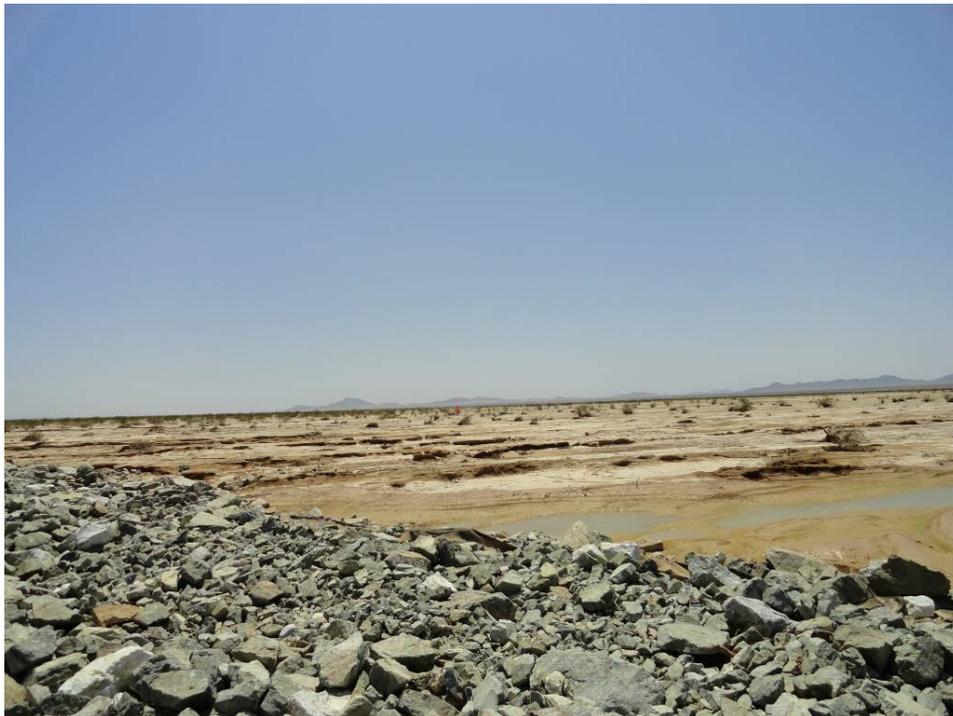
Figure 18. Channel D dissipation area along the southern site boundary (August 6, 2012)

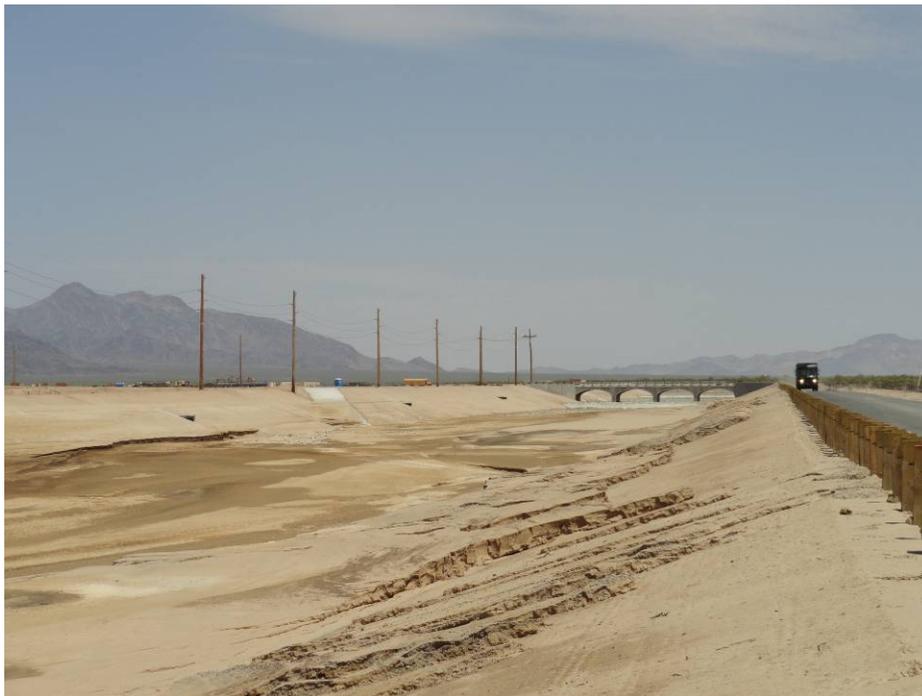
Figure 19. Residual Sediments in Channel D (August 6, 2012).

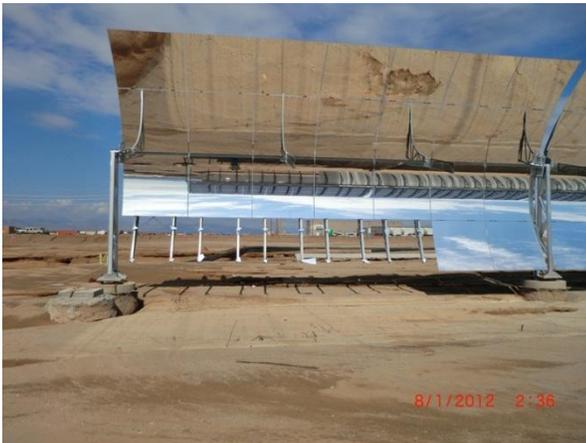
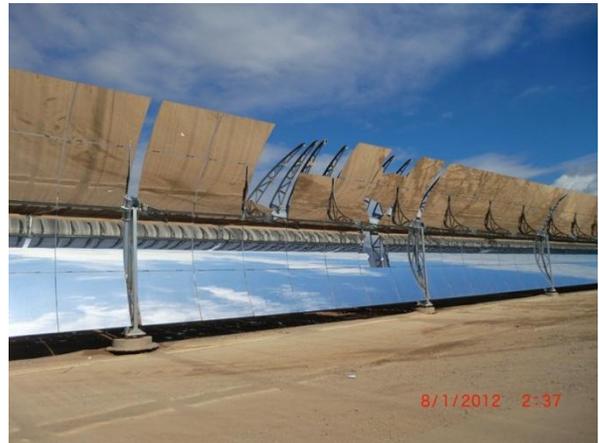
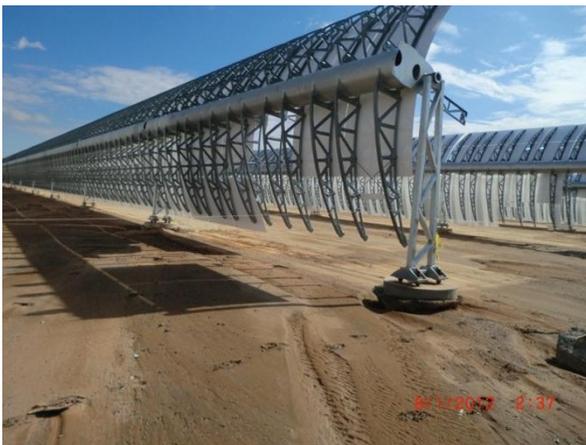
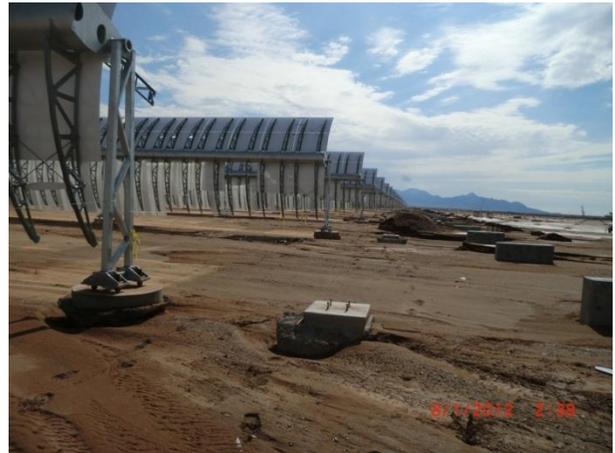
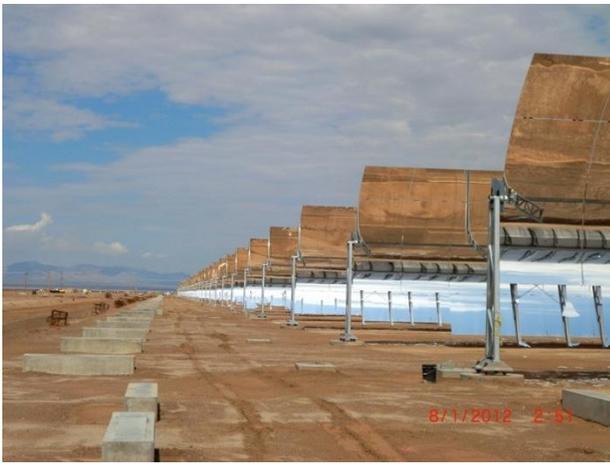
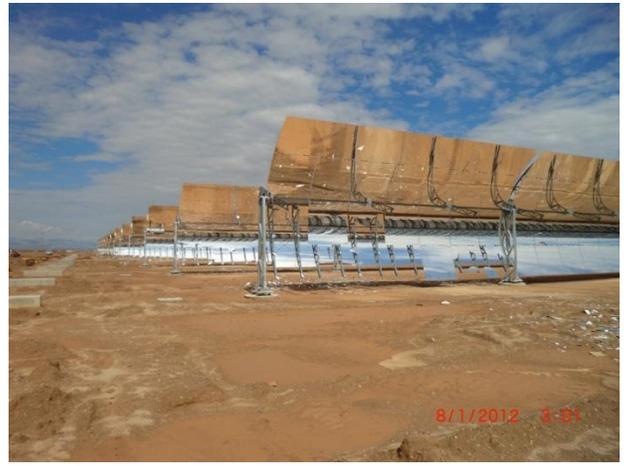
MIRROR DAMAGE TO SOLAR FIELD #2 RING #1

The mirror damage in unit 2 was due to high winds during construction. The 195 mirrors damaged were more at risk due to incomplete wind fencing and the southern end of block 1 being more exposed to wind due to the entire designed system being incomplete at the time.

Visually inspected mirror damage to solar panel mirrors in solar field #2 ring #1 and solar field #1 ring #1. A total of 195 mirrors were broken in solar field #2 ring #1 due to flood rains and high winds, most of the damage was at the south end panels, mostly at bottom, top and middle of panels, refer to drawings #s A4PA-2-UG-6-110 to A4PA-2-UG-6-112. Solar field #1 ring #1 all solar panels had no damage.

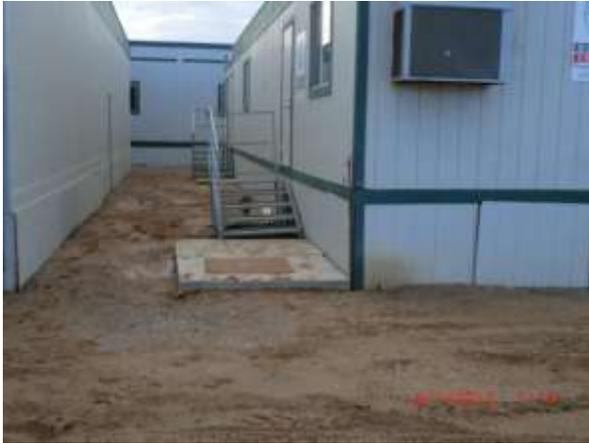
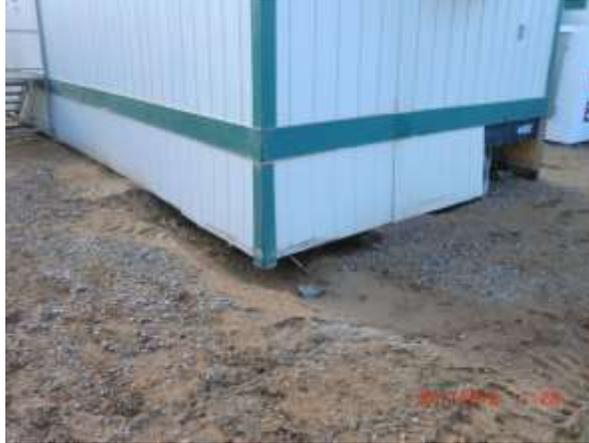
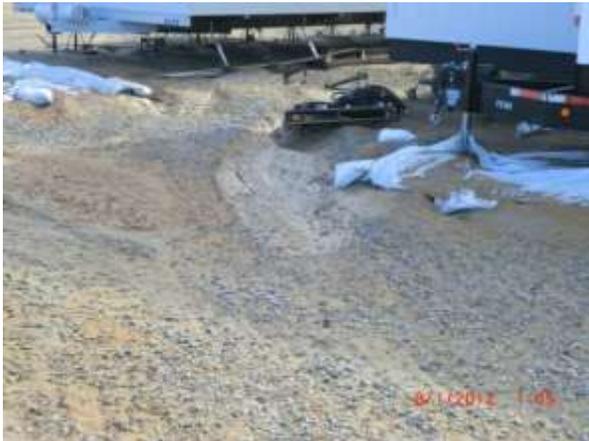
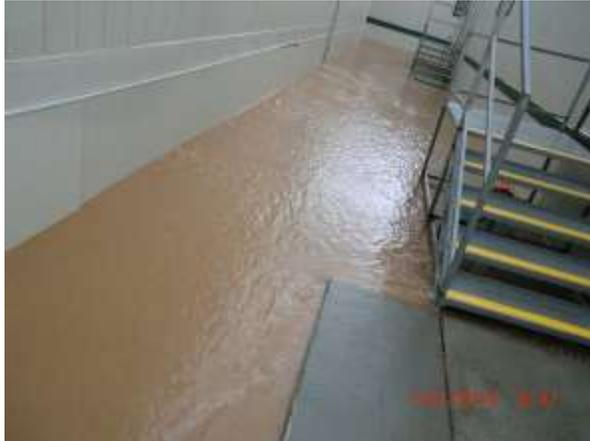
TRAILER AND LANDING DAMAGE

Visually inspected damage to trailers and landings due to heavy rain and flooding most of the damage was erosion at base of trailers ,1st trailer at north end had 3 support jacks and mud sills were washed away trailer is still in tact , bureau veritas trailer has west end landing that sunk and is out of level landing is taped off and not in use for safety issues . Did not see any water damage at wood siding to subgrade on all trailers . See attached photos.

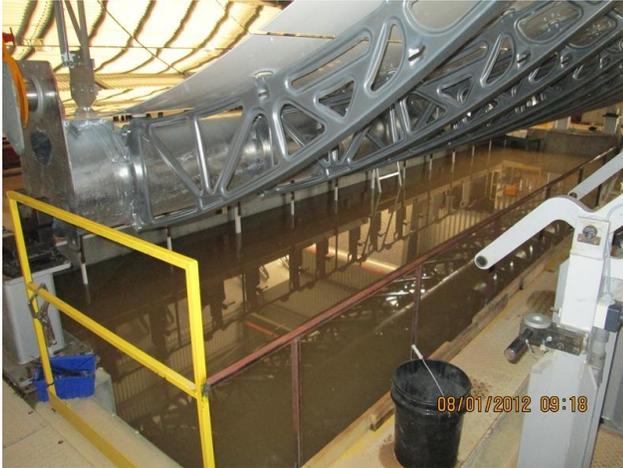
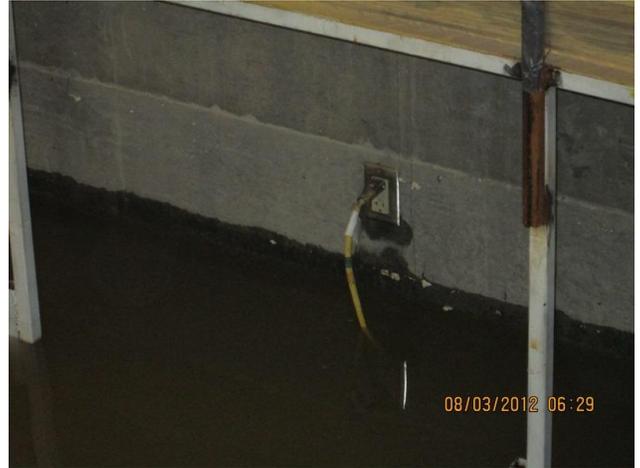
Due to the flooding of the pits at both the north and south ends of the Assembly Building a total of four GFCI receptacles were submerged in water. All four GFCI receptacles were changed out and tested by a Bureau Veritas inspector and are approved for use. The building was then tested by Newtron to insure proper function and integrity of the electrical system. No other storm related issues were reported and the building is back in normal operation.

Both pits were flooded and all GFCI receptacles were replaced

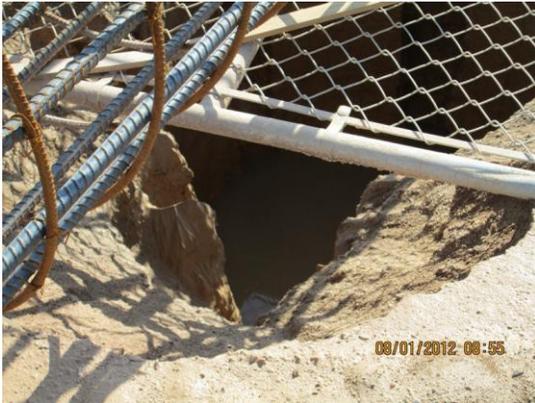
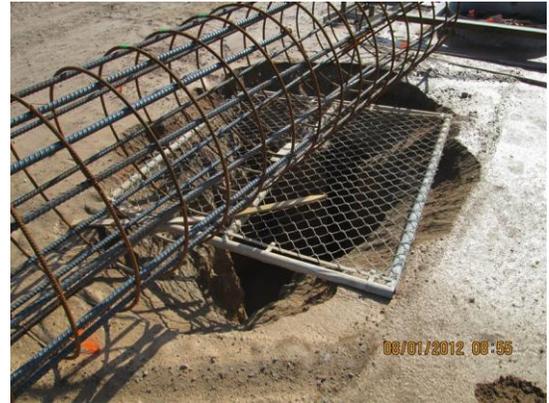
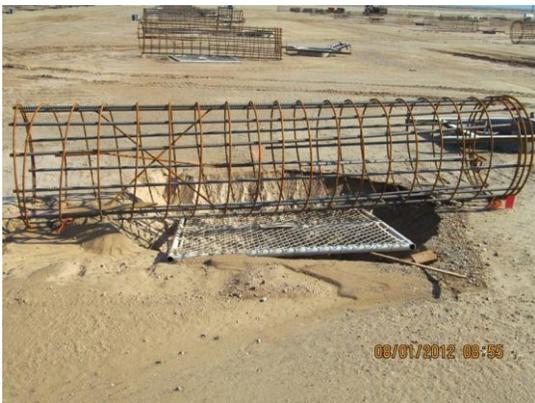
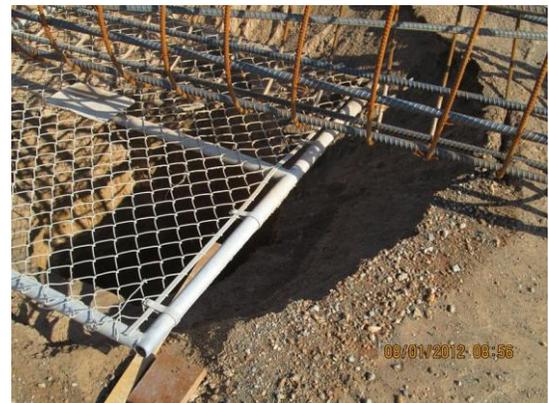
Caisson damage field 1

The following pictures will show damage to caisson holes that have been drilled and rebar cages have been set in place, ready for concrete pour. Because of flooding caisson holes filled up with mud and water. Approximately 80 caisson holes are going to be re-drilled after rebar cages are taken out with fork lift and holes have dried up. About 60 % of the rebar cages taken out are being destroyed. Also the top of the caisson holes have been eroded to twice the diameter, Largo will fill in hole , get compaction , and then re-drill hole and set in new cages.

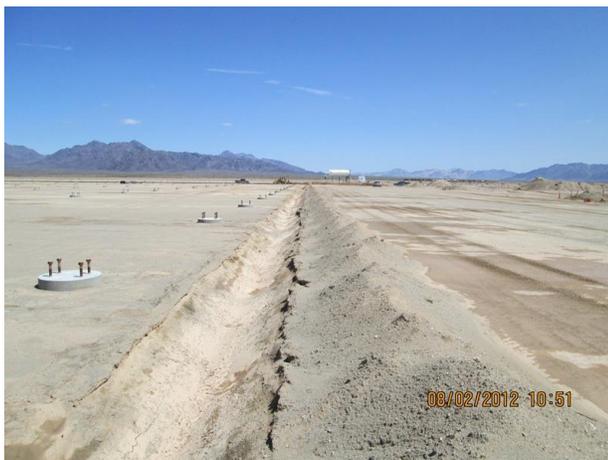
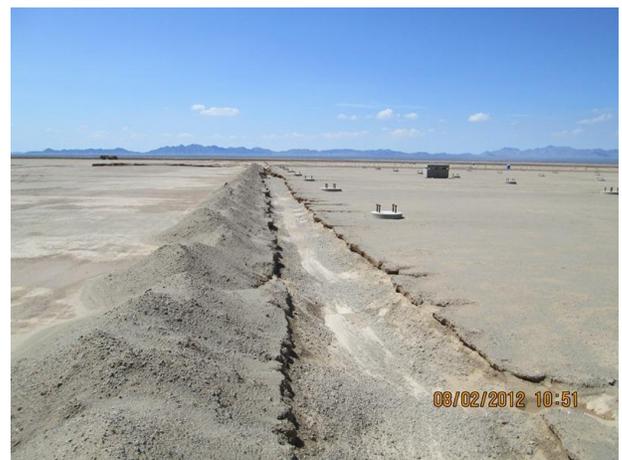
Solar Field 1 East End of Ring 3 and 4 North and South Lateral Trench

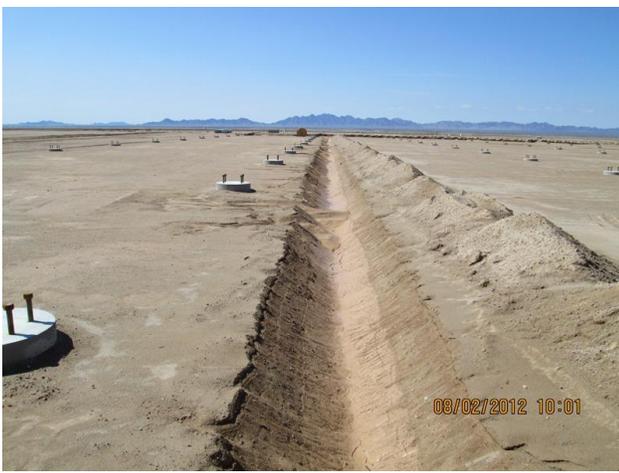
Solar Field 2 Ring 2 North South Trench East End

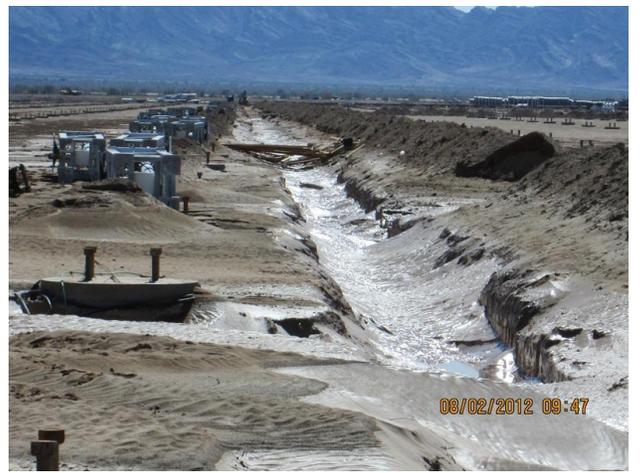
Solar Field 2 Ring 2 North Trench

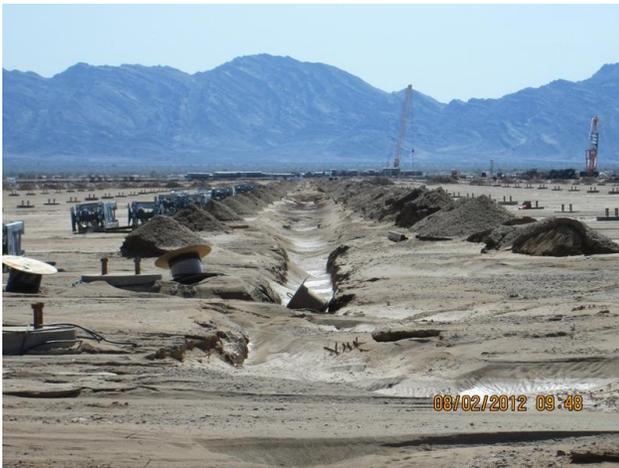
Solar Field 2 Ring 2 South Trench

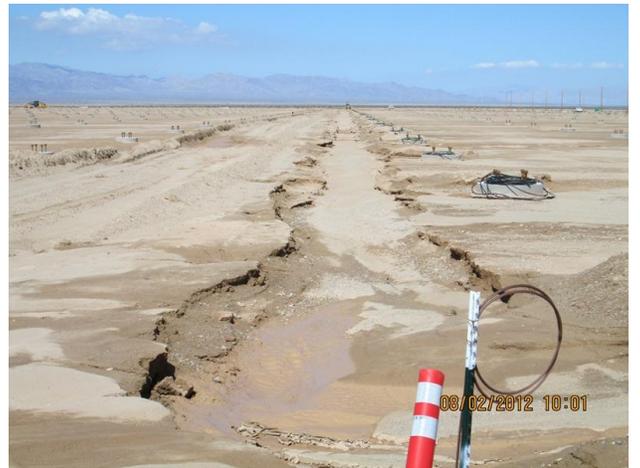
Solar Field 2 Ring 4 North South Trench East End

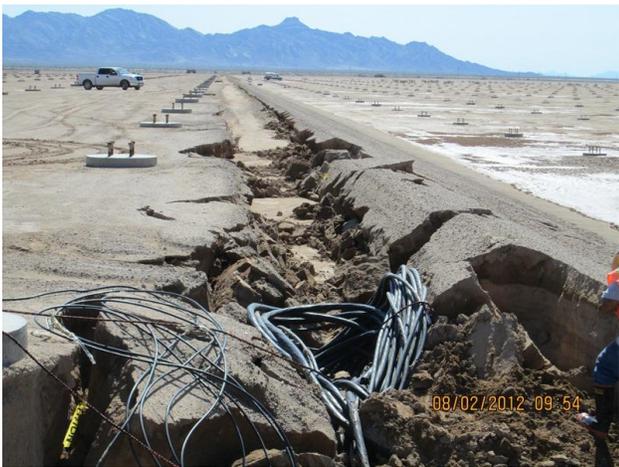
Solar Field 2 Ring 4 North South Trench Middle

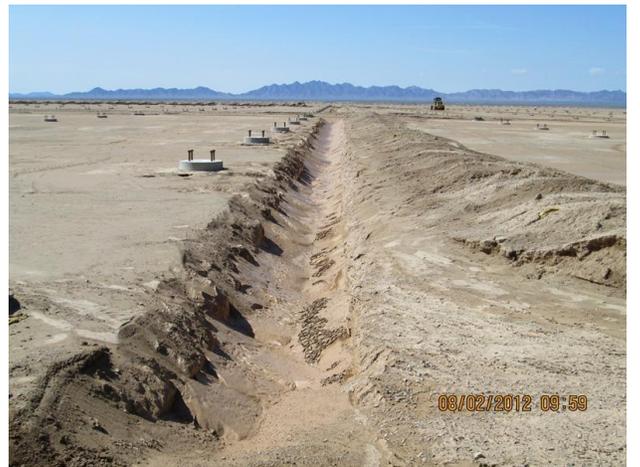
Solar Field 2 Ring 4 North Trench

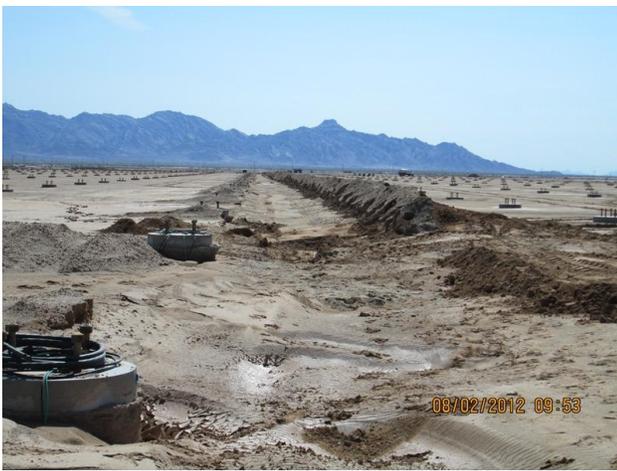
Solar Field 2 Ring 4 South Trench

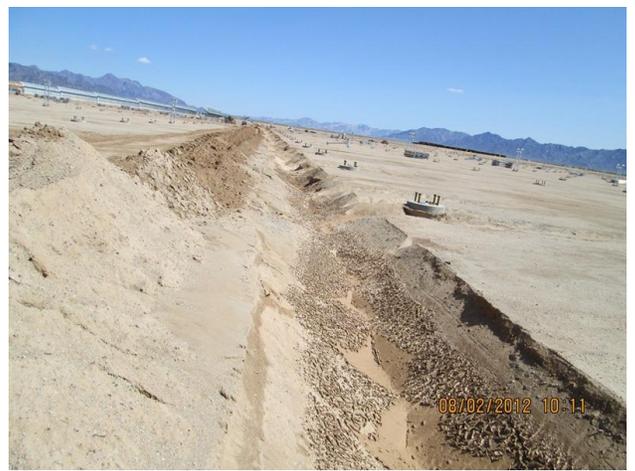
Solar Field 2 Ring 7 North South Trench Middle

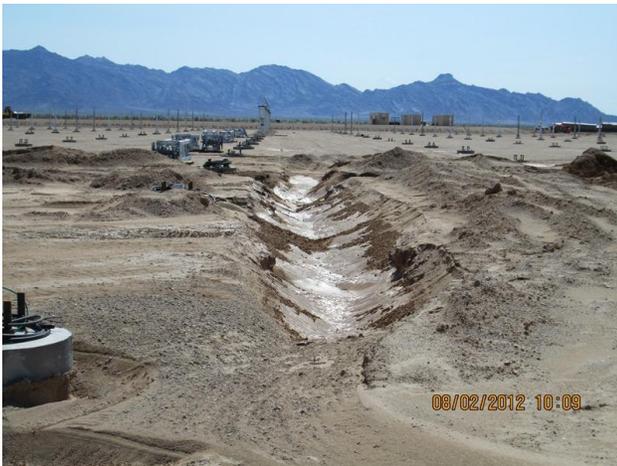
Solar Field 2 Ring 7 North Trench Partial

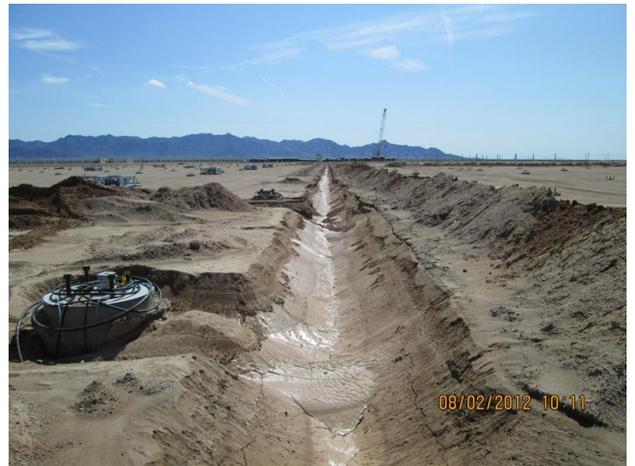
Solar Field 2 Ring 7 South Trench

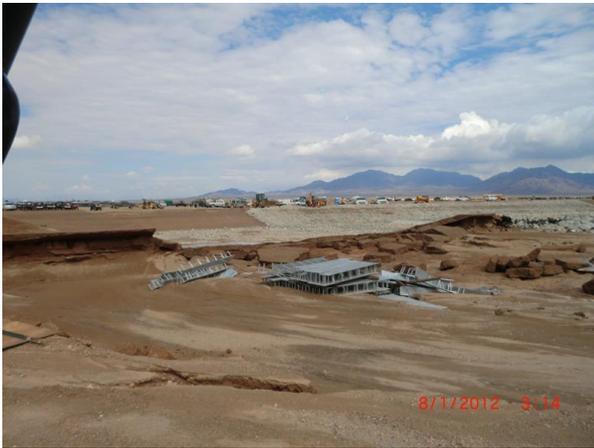
Flood waters washed massive amounts of silt and sand into the bottom of diversion trench job wide. Channel B-C at the temporary crossing overflowed causing extensive erosion damage to the banks of the channel. Channel D at the temporary crossing by the entrance to the site overflowed causing the road to be completely washed out along with massive amounts of silt. A temporary road was cut in order to evacuate remaining personnel on site. Minimal damage to the rip-rap was noticed. The V-ditch west of Solar Field 2 Block 2 and Block 3 sustained erosion damage and was filled completely with silt runoff. A large portion of the V-ditch was destroyed and will need to be replaced. Minimal damage to the A and B channels was noticed.

Damage to east side of channel B-C

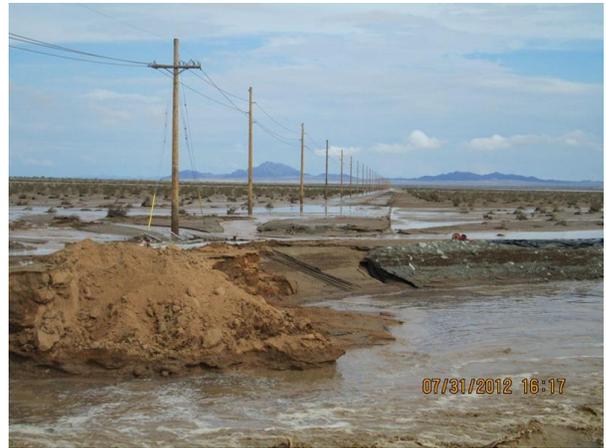
Main entrance road to jobsite

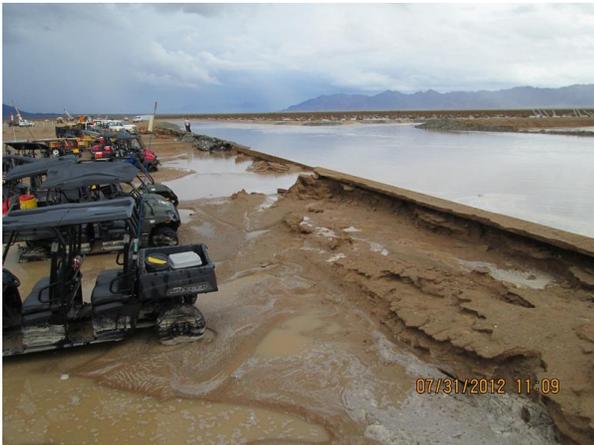
Damage to west side of channel B-C

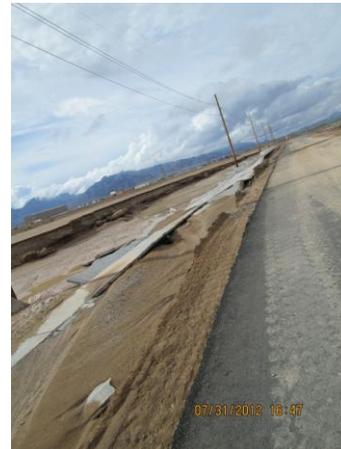
V ditch west end of field 2

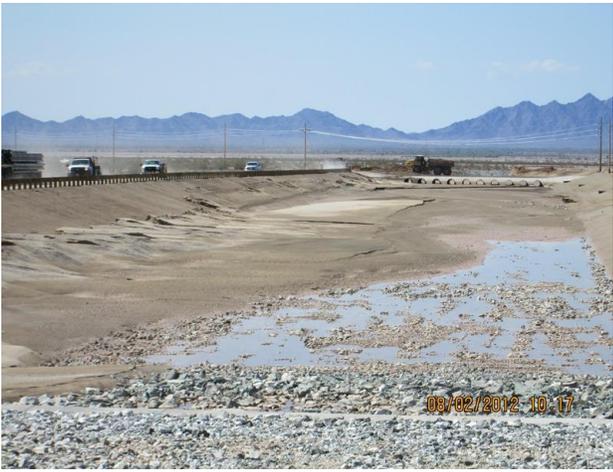
Silt in D channel
