Report on July 30-31, 2012 Storm Event at the Genesis Solar Energy Project Construction Site

Eric Veerkamp, Compliance Project Manager
Mike Conway, Engineering Office
Siting, Transmission and Environmental Protection Division

Summary

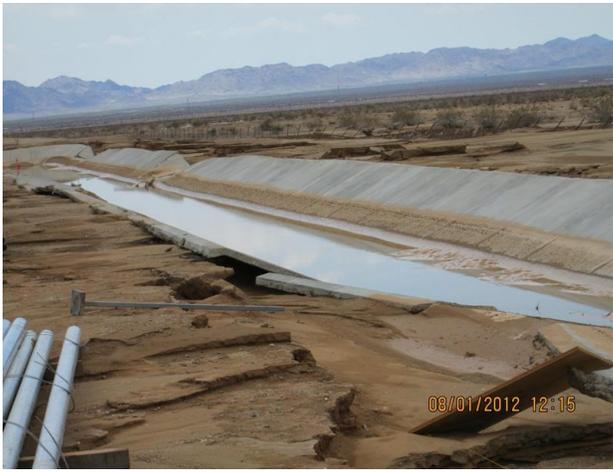
South end of V ditch

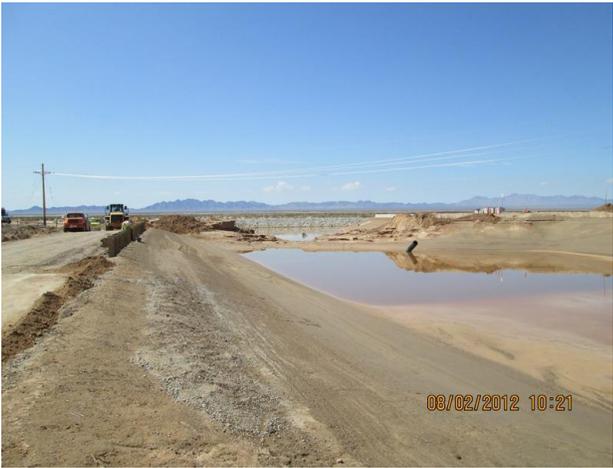
Looking south at D channel

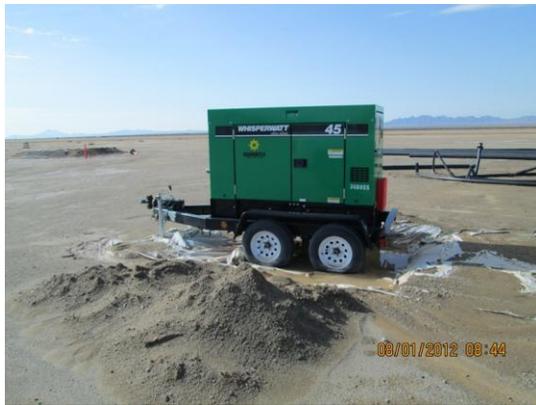
South of Power Block 1 Electronics Building 1: Generator secondary containment needs to be rebuilt.

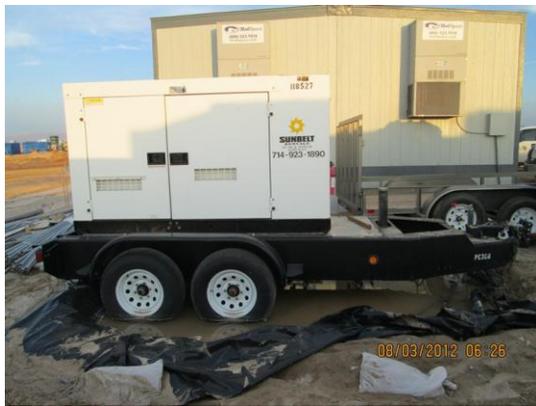
ARB trailers south of the Assembly Building: Generator secondary containment needs to be rebuilt.

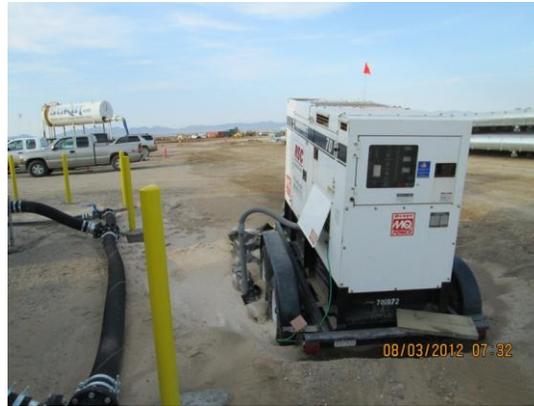
Temporary Fire Water Tanks: Generator needs to be taken out of the sink hole and relocated.

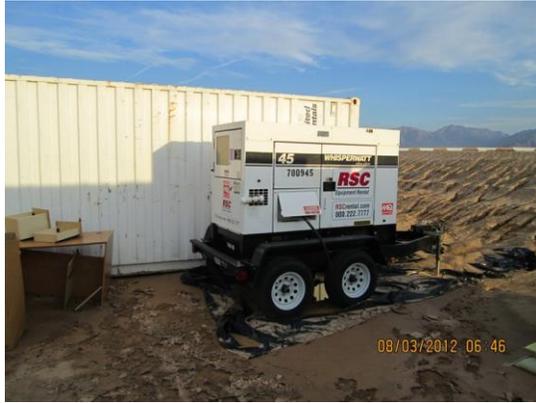
Power Block 2 PMI laydown: Generator secondary containment needs to be rebuilt.

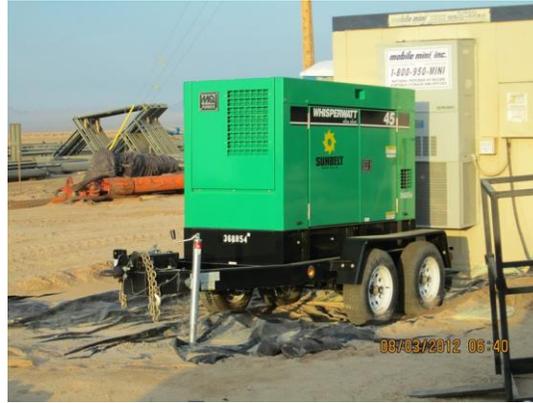
Power Block 2 South of Electronics Building: Containment needs to be rebuilt.
